Model: AT-C2.5	Date: 22-Oct-10	No.: RD087001n
----------------	-----------------	----------------

Subject: Firmware Release Note: System/Copy		Prepared by: Y. Taniguchi	
From: 1st Tech Service Sect., MFP/Printer Tech Service Dept			
Classification:	<input type="checkbox"/> Troubleshooting	<input type="checkbox"/> Part information	<input type="checkbox"/> Action required
	<input type="checkbox"/> Mechanical	<input type="checkbox"/> Electrical	<input type="checkbox"/> Service manual revision
	<input type="checkbox"/> Paper path	<input type="checkbox"/> Transmit/receive	<input type="checkbox"/> Retrofit information
	<input type="checkbox"/> Product Safety	<input checked="" type="checkbox"/> Other (Firmware)	<input checked="" type="checkbox"/> Tier 2

This RTB has been issued to announce the firmware release information for the **System/Copy**.

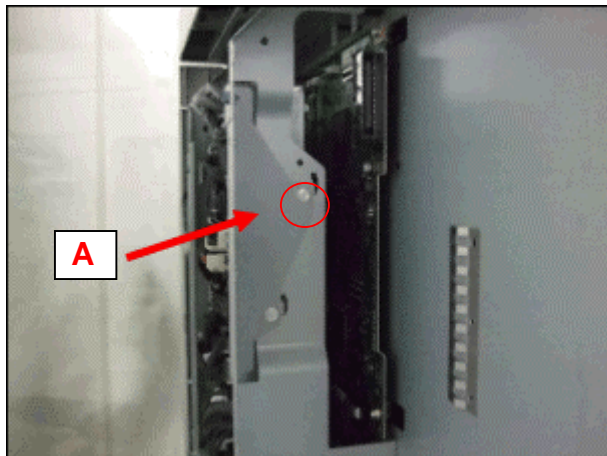
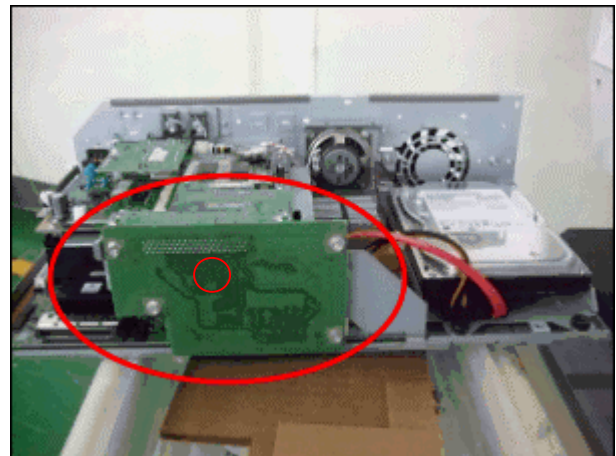
The screw [A] shown below touches the fax I/F board, causing a short circuit.

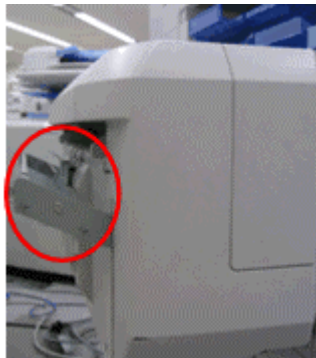
SC798 is displayed when the SR3050 (D372) is unpacked or installed, ***or later during machine operation if the lift sensor switch or motor was damaged during machine installation.***

- ***The section of the exit tray circled in the photo below is contacted (hit) during the shipping process, or***
- ***The customer lifts the tray all the way up***

- ***If the symptom occurs at machine installation, do Procedure 1 below.***
- ***If the symptom occurs during machine operation after installation, do Procedure 2 below.***

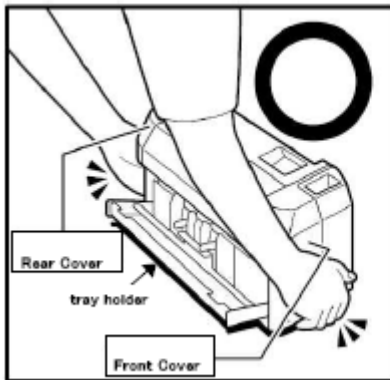
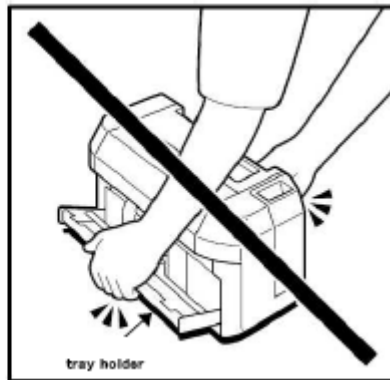
Whenever you lift or carry the SR3050, always **hold it by the bottom edges** of the front and rear covers, as shown below. If you do not, SC798 will occur when you attach the finisher. **DO NOT** hold the finisher by the tray holder.

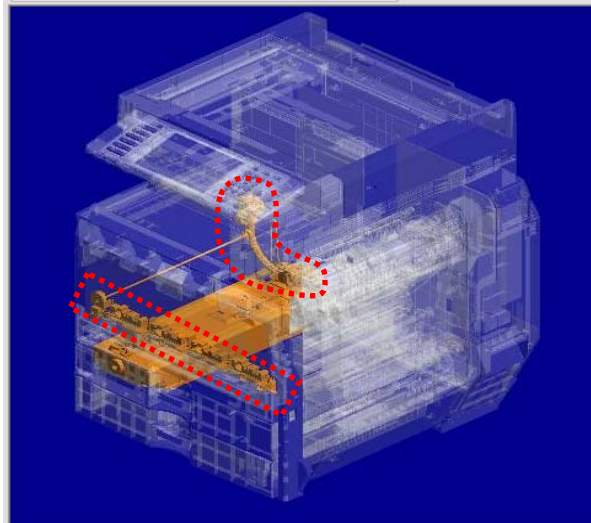
Mechanical noise is heard at the front (D0896481) and rear (D0896540) of the machine.

Note: If the noise goes unnoticed, the waste toner can overflow into the development unit or transfer belt-cleaning unit. In such cases, the machine may stop and display SC errors related to driven units.

Engine firmware bug

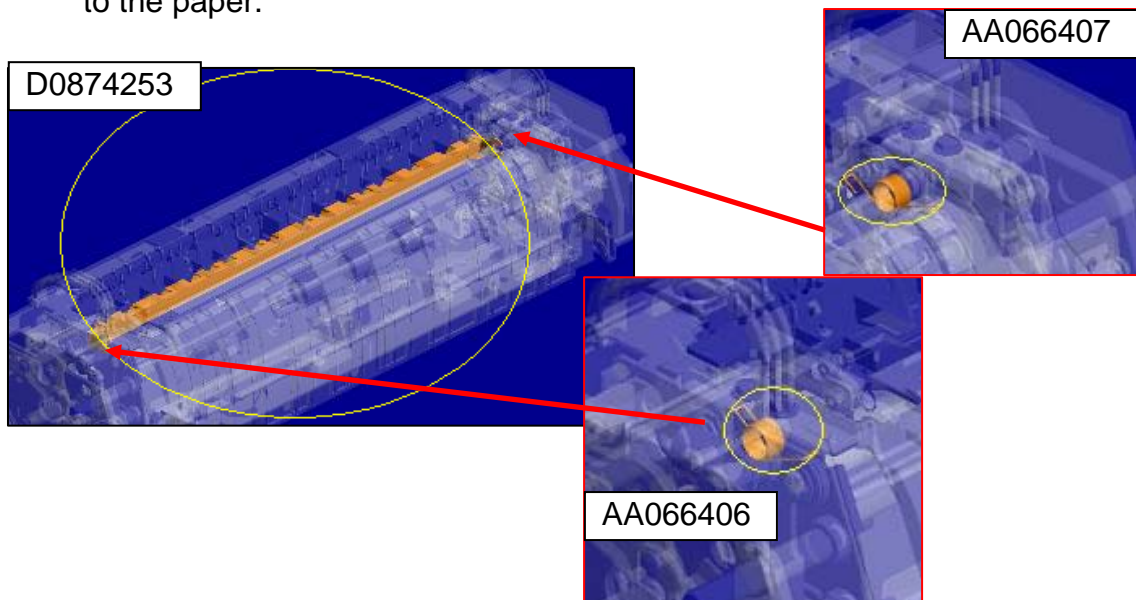
2) The shapes of the fusing exit guide and plate were changed.

Reason: To ensure that condensation that can form on the stripper plate is not transferred to the paper.

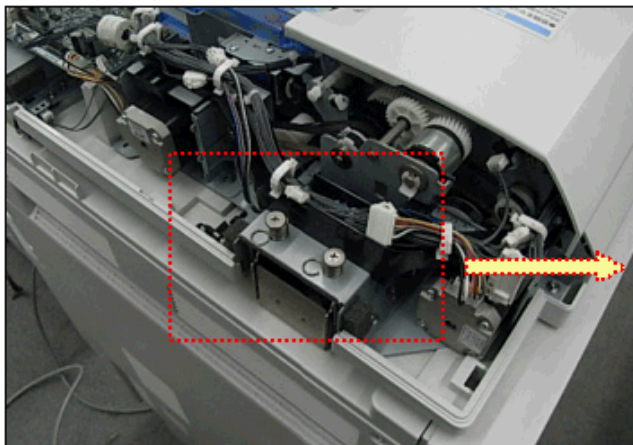
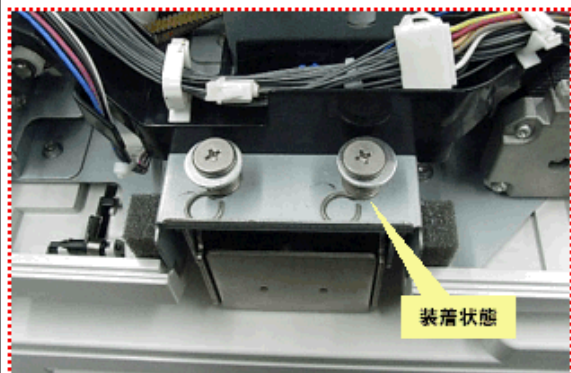
If a thick spacer is used, the pressure at the front side may increase too much. Make sure that jams or dog ears do not occur after installing the spacers.

Replace Hinge: Left (D3661271) with the new part (D5411271).
