Model: AT-C2.5	Date: 07-Feb-12	No.: RD087044
----------------	-----------------	---------------

Subject: Dog ear or Jam on ADF3050		Prepared by: N.Yoshida	
From: 1st Tech Service Sect., MFP/P Tech Service Dept.			
Classification:	<input checked="" type="checkbox"/> Troubleshooting	<input type="checkbox"/> Part information	<input checked="" type="checkbox"/> Action required
	<input type="checkbox"/> Mechanical	<input type="checkbox"/> Electrical	<input type="checkbox"/> Service manual revision
	<input type="checkbox"/> Paper path	<input type="checkbox"/> Transmit/receive	<input type="checkbox"/> Retrofit information
	<input type="checkbox"/> Product Safety	<input type="checkbox"/> Other ()	<input checked="" type="checkbox"/> Tier 2

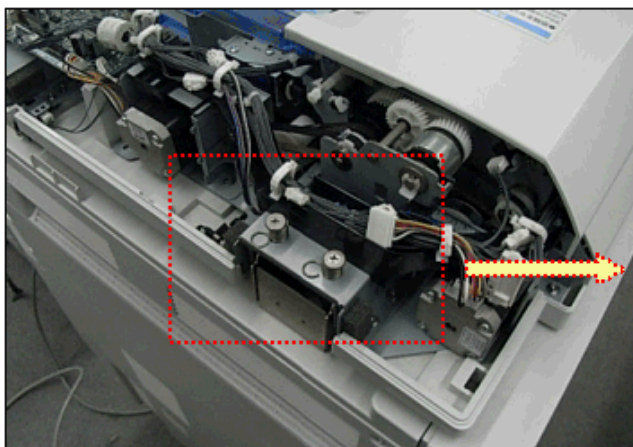
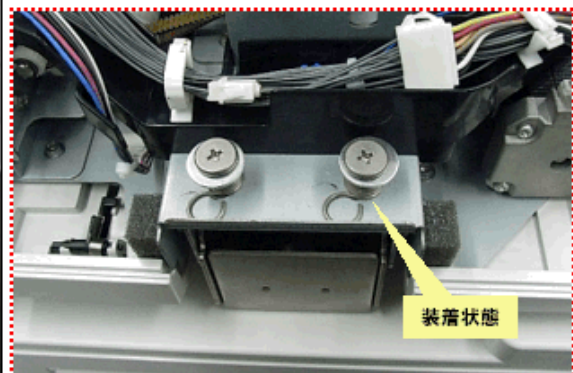
Dog ear or jam occurs at the rear side of the original document when the original is fed through the ADF.

Torque of the hinge increases with time and it can create an imbalance in the pressure applied to the original between the front and rear sides of the ADF.

Remove the following stud screws and reinstall them with a white spacer (07080080N) under each screw.

If a thick spacer is used, the pressure at the front side may increase too much. Make sure that jams or dog ears do not occur after installing the spacers.

Replace Hinge: Left (D3661271) with the new part (D5411271).

The shape of the new hinge reduces the tendency for torque to increase over time.
