Model: AT-C1 Booklet Finisher (SR3000)	Date: 25-Jul-08	No.: RB793001a
--	-----------------	----------------

Subject: Firmware Release Note: Booklet Finisher		Prepared by: N.Yoshida	
From: 2nd Tech. Support Sec. Service Support Dept.			
Classification:	<input type="checkbox"/> Troubleshooting	<input type="checkbox"/> Part information	<input type="checkbox"/> Action required
	<input type="checkbox"/> Mechanical	<input type="checkbox"/> Electrical	<input type="checkbox"/> Service manual revision
	<input type="checkbox"/> Paper path	<input type="checkbox"/> Transmit/receive	<input type="checkbox"/> Retrofit information
	<input checked="" type="checkbox"/> Other ()

Model: AT-C1 Booklet Finisher (SR3000)		Date: 15-Jun-09	No.: RB793002
Subject: SR3000 Jam		Prepared by: M. Kumagai	
From: 2nd Tech Support Sec. Service Support Dept.			
Classification:	<input checked="" type="checkbox"/> Troubleshooting	<input type="checkbox"/> Part information	<input type="checkbox"/> Action required
	<input type="checkbox"/> Mechanical	<input type="checkbox"/> Electrical	<input type="checkbox"/> Service manual revision
	<input type="checkbox"/> Paper path	<input type="checkbox"/> Transmit/receive	<input t

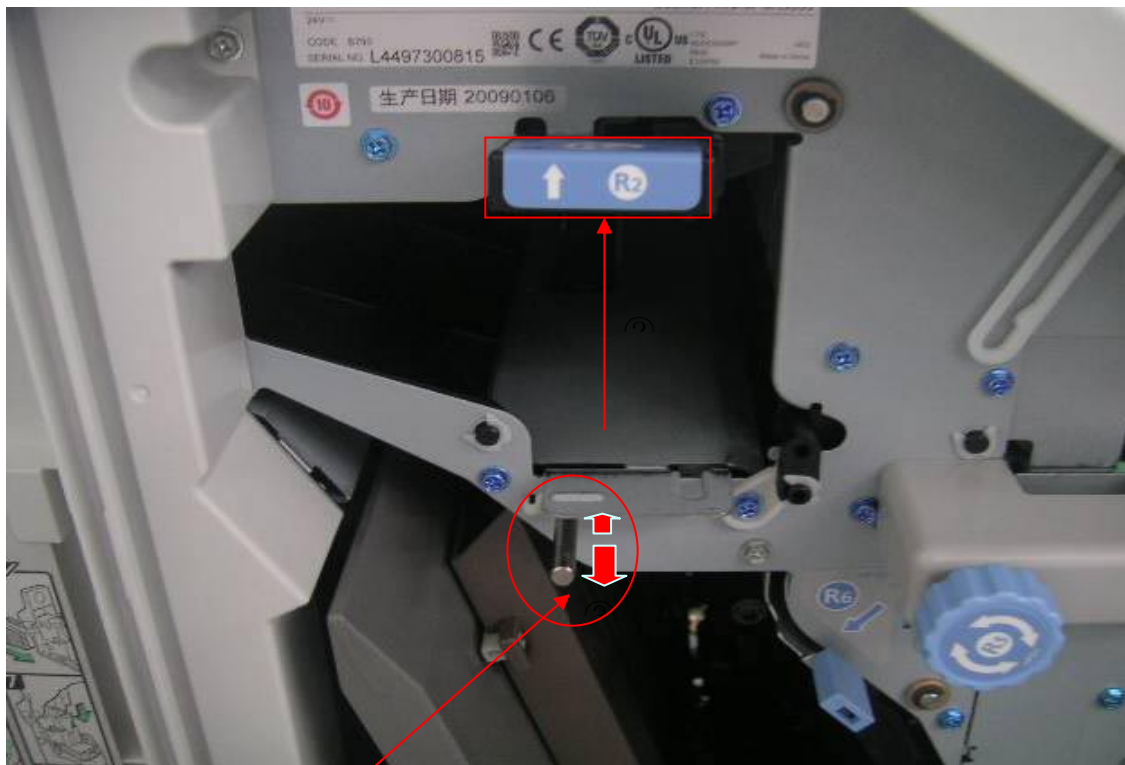
Photo 1

Paper jams may occur after installation of the SR3000 finisher.

The rotation of the four SR3000 motors is not checked when the SR3000 is installed. As a result, the dried vaporized glue on the motor shafts causes the motors to lock.

1. Open the front cover of the finisher.
2. Pull up the “R2” shift guide.
3. Move the shift roller shaft (circled in red) back and forth slowly. **Do not** turn the shaft.
Note: This will cause the shift motor (**B7935817**) to rotate.

IMPORTANT: Only move the shaft back and forth. **Do not** rotate.

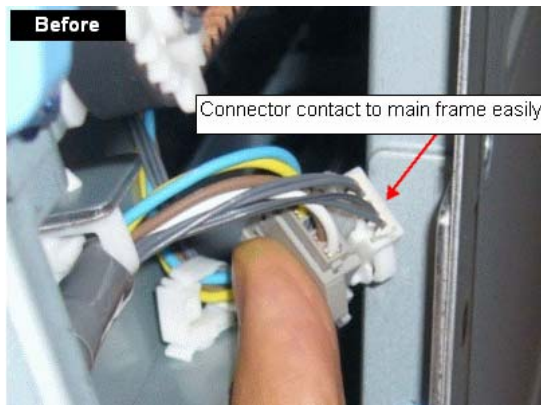
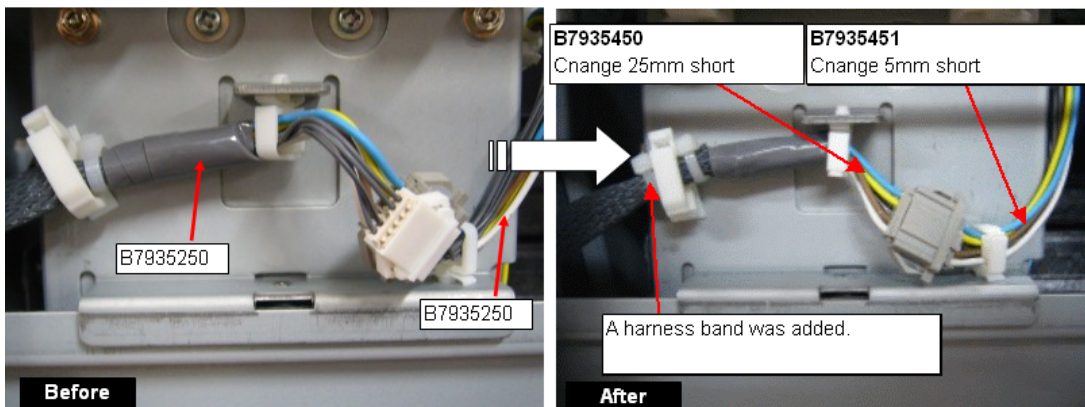
Change / Reason: The lengths of the following harnesses were changed to prevent connectors contacting the main frame.

Old parts number	New parts number	Description	Q'ty	Int	Page	Index
B7935250	B7935450	HARNESS:STAPLER	1	X/O As a Set	23	24
B7935251	B7935451	HARNESS:CONNECTIN G:STAPLER	1		23	23

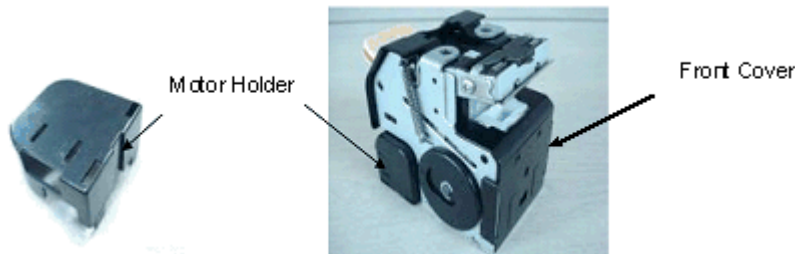
Some parts of the stapler unit (black resin parts shown below) contained PBDE material in excess of the limits set by the RoHS Directive.

The vendor of these parts used irregular materials during the manufacturing process. Production period: June to September 2010 (refer to the S/N table below)

Replace the stapler unit.

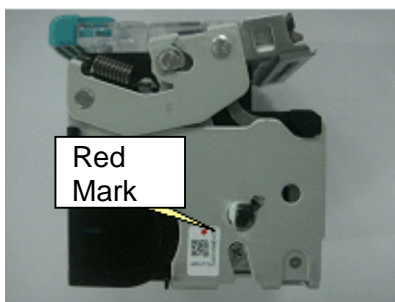
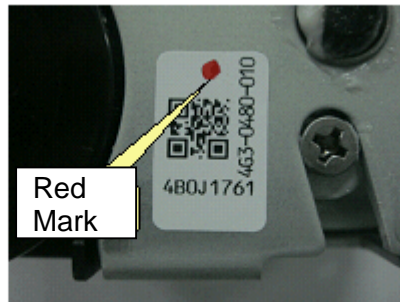
Important: Stapler units on some of these affected finishers have already been replaced with the normal ones. If there is a **red dot** on the stapler unit's label (see the photo below), you **do not need to replace** these units.
