Model: Model-J CF/J-P2 CF/J-C1/J-C2/AT-C1/AP-C1/ Adonis-C3/Adonis-C4/Adonis-C4.5 Platen Cover (Type 3800C)	Date: 11-Oct-07	No.: MG329001
--	-----------------	---------------

Model: Model J-C2		Date: 05-Sep-07	No.: RB178044
Subject: Platen cover sheet damage		Prepared by: S.Yoshiki	
From: 1st Tech. Support Sec. Service Support Dept.			
Classification:	<input type="checkbox"/> Troubleshooting	<input type="checkbox"/> Part information	<input type="checkbox"/> Action required
	<input type="checkbox"/> Mechanical	<input type="checkbox"/> Electrical	<input type="checkbox"/> Service manual revision
	<input type="checkbox"/> Paper path	<input type="checkbox"/> Transmit/receive	<input type="checkbox"/> Retrofit information
	<input checked="" type="checkbox"/> Product Safety	<input type="checkbox"/> Other ( )

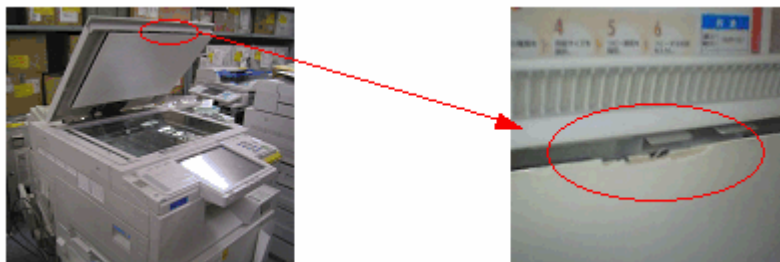
A small area on the lower front edge of the platen cover sheet is damaged. This may have a potential safety risk, depending on the amount of damage.

The platen cover is opened/closed repeatedly over a long period of time, and each time, the operator touches the platen cover sheet. As a result, this area of the platen cover sheet is gradually worn down.

Check the condition of the platen cover sheet at the next service visit.

If the platen cover sheet shows any damage:

- Remove the platen cover sheet and reattach it in the reverse orientation (turn it 180 degrees so that the damaged edge is at the rear side).
- Cover the damaged area of the platen cover sheet with transparent tape.

- Replace the platen cover sheet with the modified part:

P/N G3291371      Sheet: Pressure plate: Ass'y  
Used in platen cover options produced from: March 2007
