Model: AT-C2.5	Date: 22-Oct-10	No.: RD087001n
----------------	-----------------	----------------

Subject: Firmware Release Note: System/Copy		Prepared by: Y. Taniguchi	
From: 1st Tech Service Sect., MFP/Printer Tech Service Dept			
Classification:	<input type="checkbox"/> Troubleshooting	<input type="checkbox"/> Part information	<input type="checkbox"/> Action required
	<input type="checkbox"/> Mechanical	<input type="checkbox"/> Electrical	<input type="checkbox"/> Service manual revision
	<input type="checkbox"/> Paper path	<input type="checkbox"/> Transmit/receive	<input type="checkbox"/> Retrofit information
	<input type="checkbox"/> Product Safety	<input checked="" type="checkbox"/> Other (Firmware)	<input checked="" type="checkbox"/> Tier 2

This RTB has been issued to announce the firmware release information for the **System/Copy**.

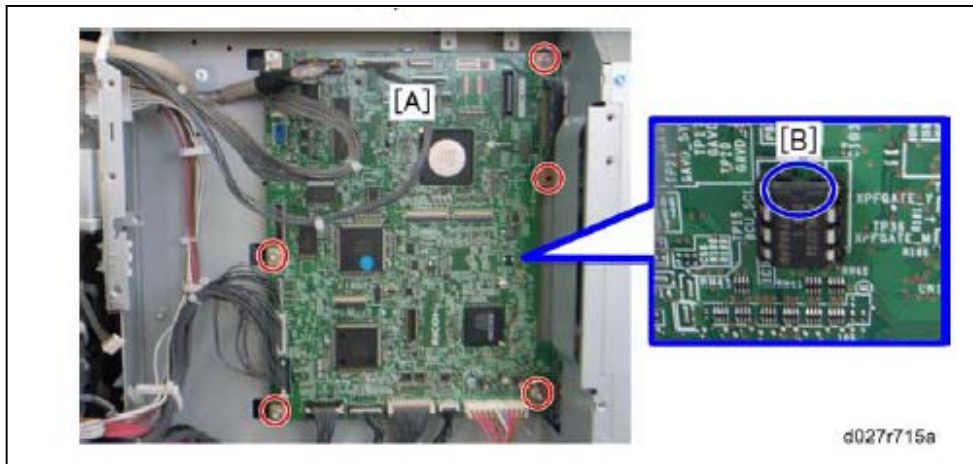
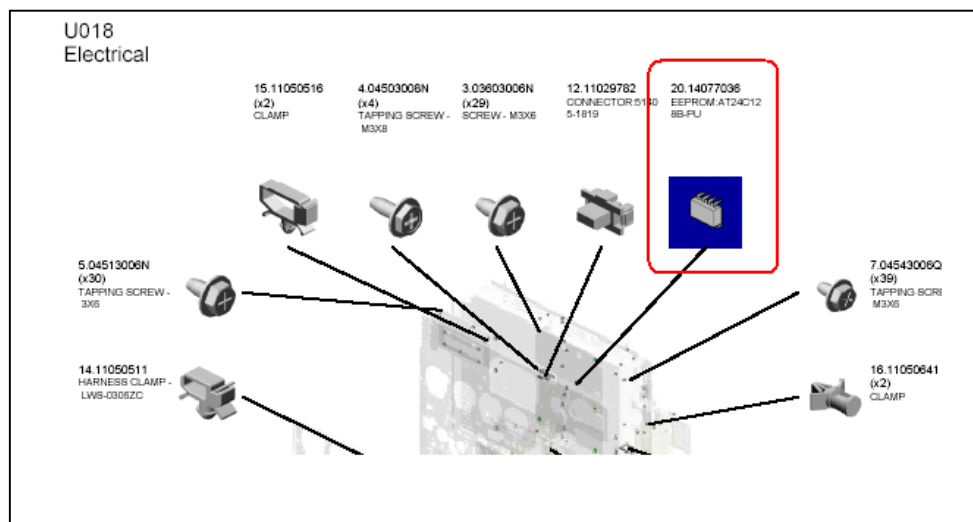
(1) NVRAM on the BICU

The NVRAM on the BICU is shown above as [B] on the BICU board [A] (See Pg. 313 in the FSM)

The NVRAM on the BICU is called 'EEPROM' in the parts catalog on page "U018 Electrical".

1. Output the SMC data ("ALL") using SP5-990-001.
2. Turn off the main switch.
3. Remove the VM card from SD card Slot #2 (lower slot).
4. Insert a blank SD card into Slot #2, and then turn on the main power switch.
5. Upload the NVRAM data to the blank SD card using SP5-824-001 (NVRAM Data Upload).
6. Turn off the main power switch, and then unplug the AC power cord.
7. Remove the SD card containing the NVRAM data from Slot #2.
8. Replace the NVRAM on the ***Controller Board*** with a new one.
9. Plug in the AC power cord, and then turn ON the main power switch.

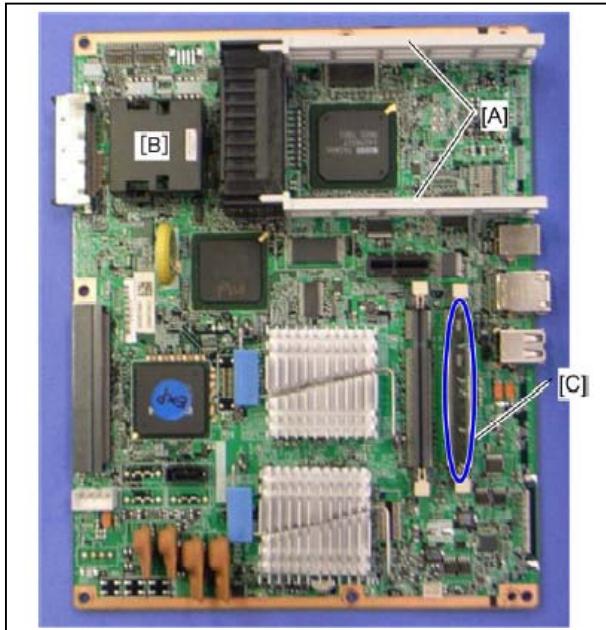
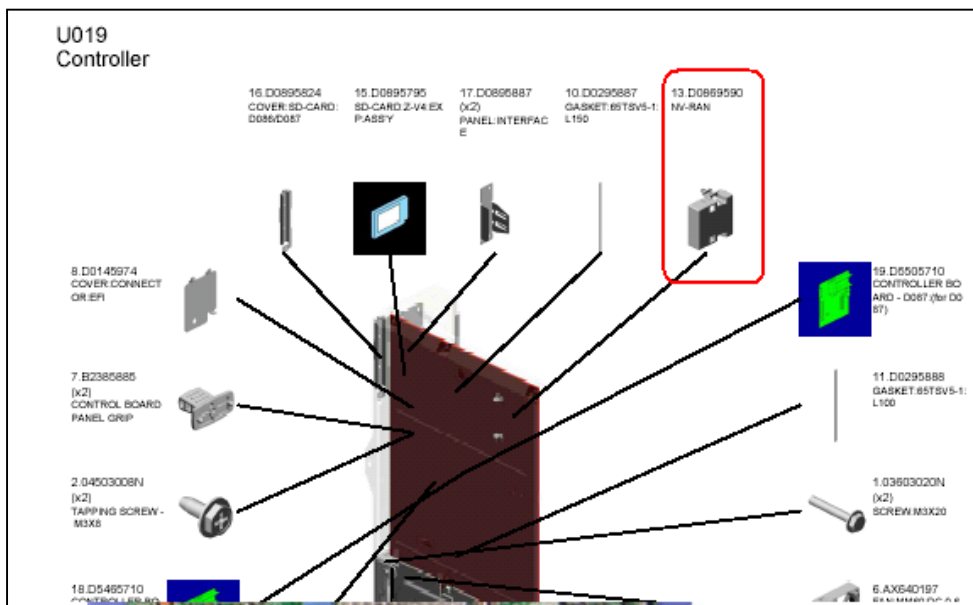
(2) NVRAM on the Controller Board

The NVRAM on the Controller Board is shown as [B] in the above photograph (See Pg. 318 in the FSM).

The NVRAM on the Controller Board is also called 'NVRAM' in the parts catalog on page "U019 Controller".

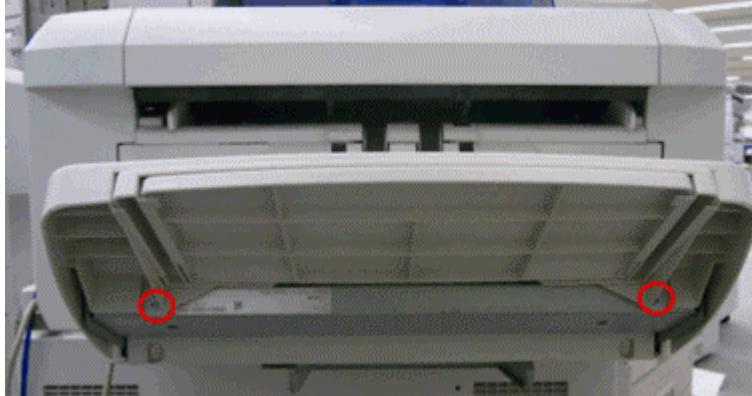
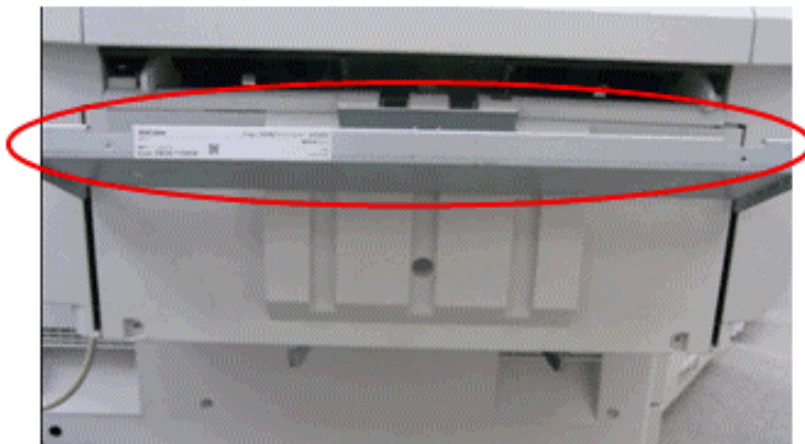
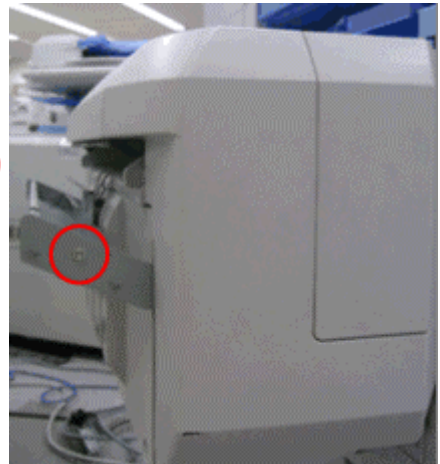
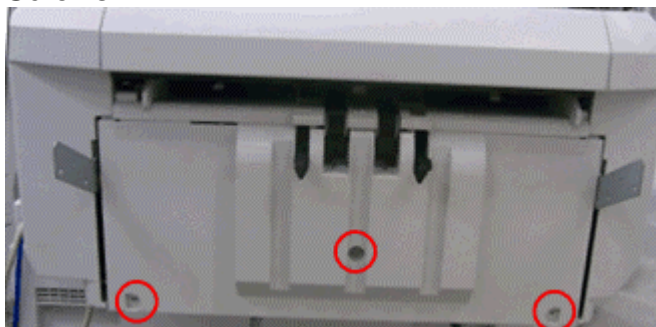
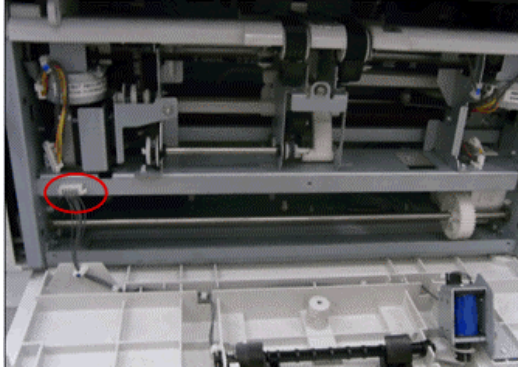
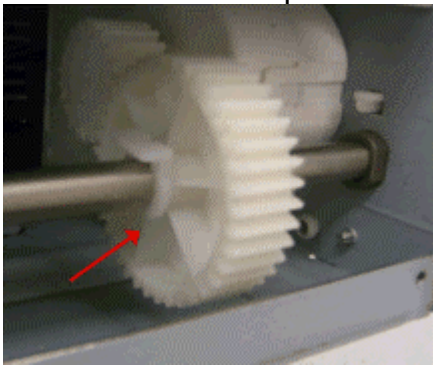
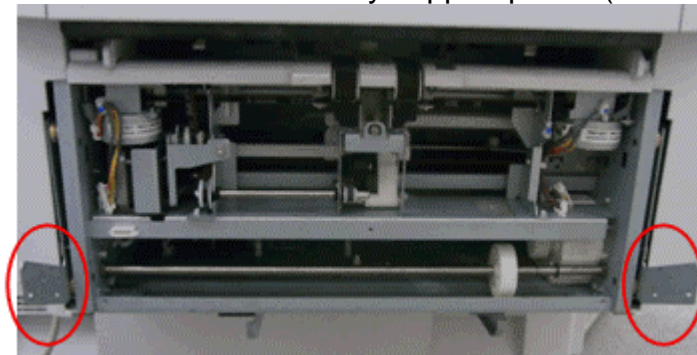
SC798 is displayed when the SR3050 (D372) is unpacked or installed, ***or later during machine operation if the lift sensor switch or motor was damaged during machine installation.***

1. Turn OFF the main power switch.
2. Remove the shift tray (screws x 2).

3. Remove the shift tray bracket (screws x 2).

4. Remove the end fence (screws x 3, connector x 1).

5. Remove the snap attached beside the gear (snap x 1).

6. Push down the two tray support plates (left and right sides) all the way.

7. Attach the above gear and snap (snap x 1).

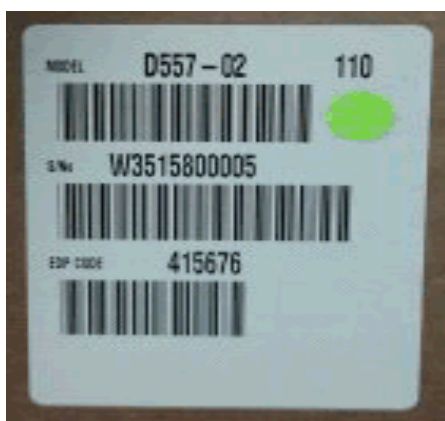
Under the conditions described above, a program bug with the 1-1AEV71 patch causes the controller to send the delete command for the wrong pages (pages not yet printed out).

A modified patch (1-1C5GYZ) has been applied to machines in production from November 1, 2011. These units have a green dot on the bar code label, as shown below.

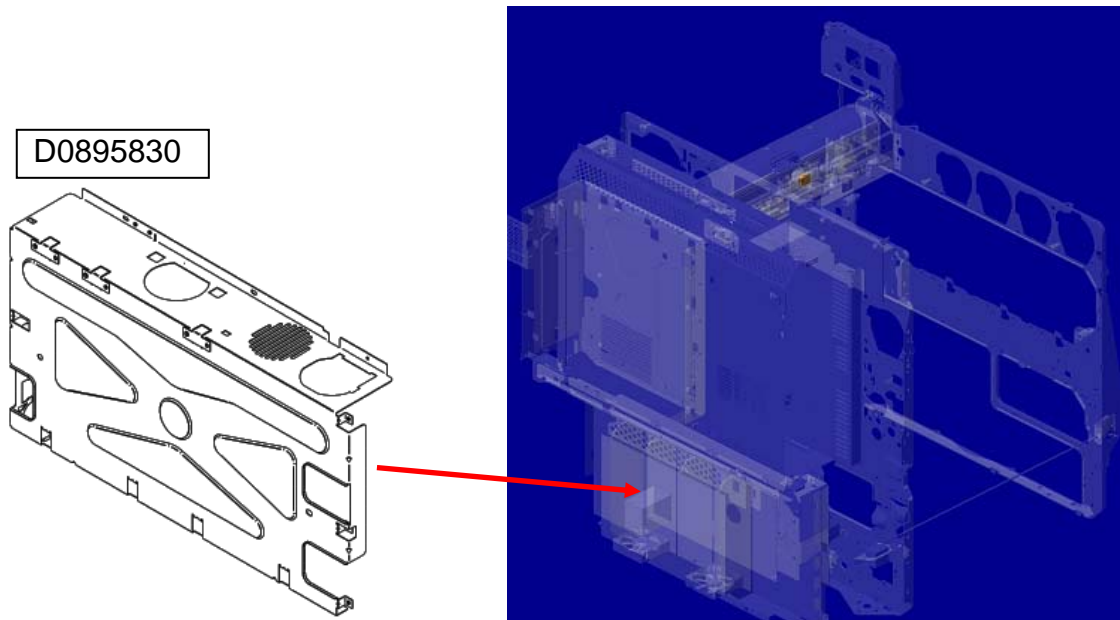
Change: The PSU bracket was added as a service part.

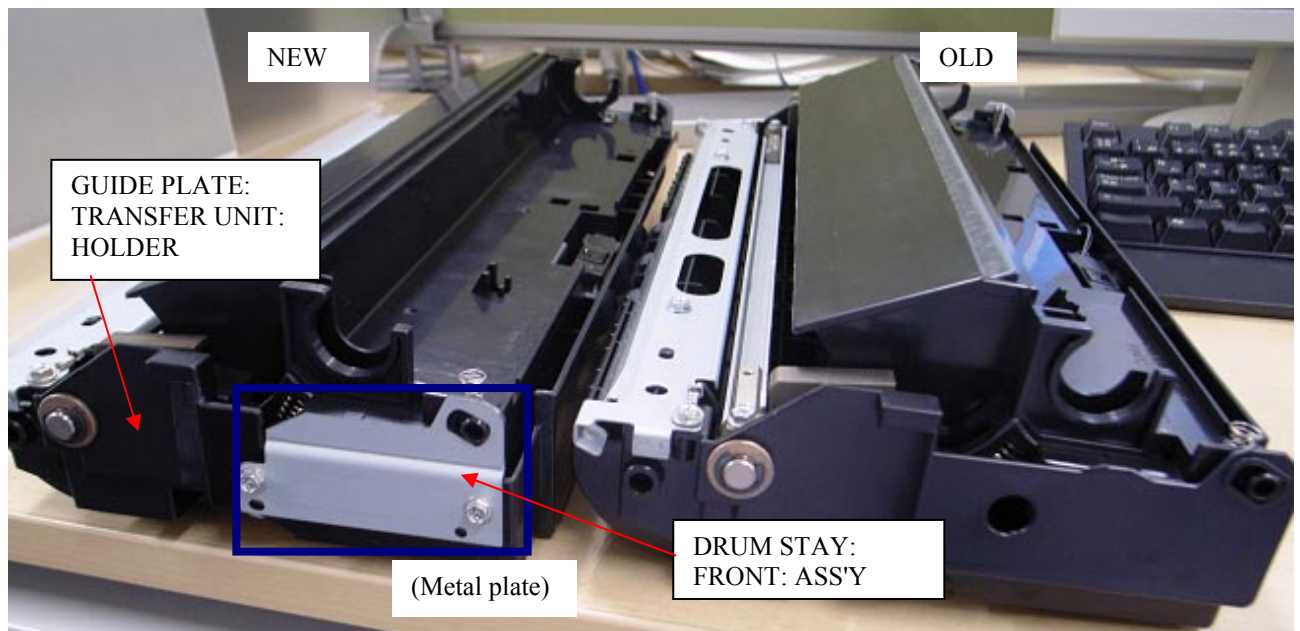
Reason: To further increase the load-bearing strength of the parts.

Important: Interchangeability is **X/O as a set** (all six parts together).

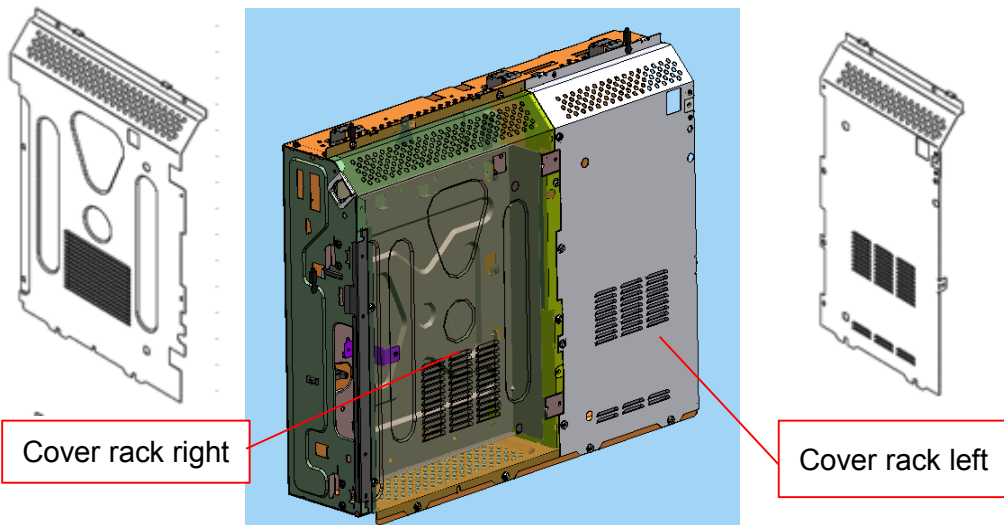
Cover rack right: D0295811

Cover rack left: D0295810

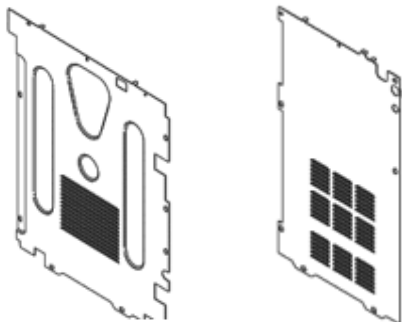
AP-P2

Cover rack right: G1335811

Cover rack left: G1335810
