# Notes for Users

This supplement provides notes and corrections for the manuals provided with this machine. Read this supplement in conjunction with the relevant manual.

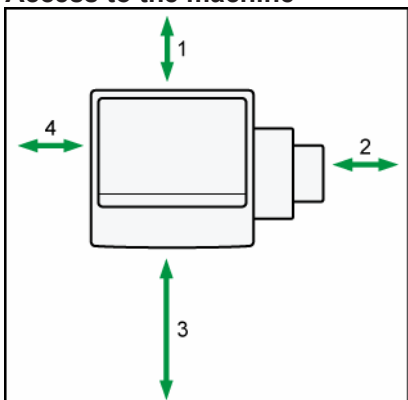
CAS080

### Access to the machine

1. Rear: 10 cm (4 inches) or more
2. Right: **10 cm (4 inches)** or more
3. Front: **75 cm (29.5 inches)** or more
4. Left: 10 cm (4 inches) or more

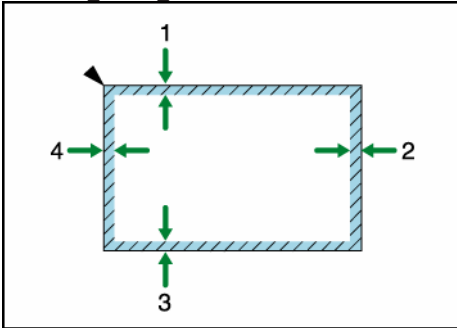
BZH047

### Missing Image Area

1. 0.5 - 4.0 mm (0.02 - 0.15 inch)

2. **0.5 - 6.0 mm (0.02 - 0.24 inch) (3.0 - 6.0 mm (0.12 - 0.24 inches) in Duplex mode)**

3. 0.5 - 4.0 mm (0.02 - 0.15 inch)

4.  $4.2 \pm 1.5$  mm ( $0.17 \pm 0.06$  inch)
